The 2025 HUB Build Northwest Awards

Project Name: Othello Community Hospital

Othello Community Hospital Tunnel Lid Replacement
Small Projects

Othello Community Hospital Tunnel Lid Replacement

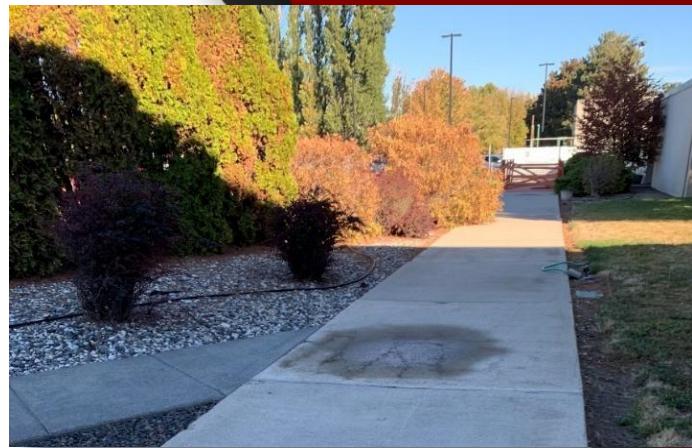
The project involved demolition of the existing tunnel lid, and the installation of a new 301 linear foot precast tunnel lid designed to blend seamlessly with adjacent sidewalks. After the project was awarded, Clearwater also assisted with the sealing sections of the tunnel walls where settlement had occurred.

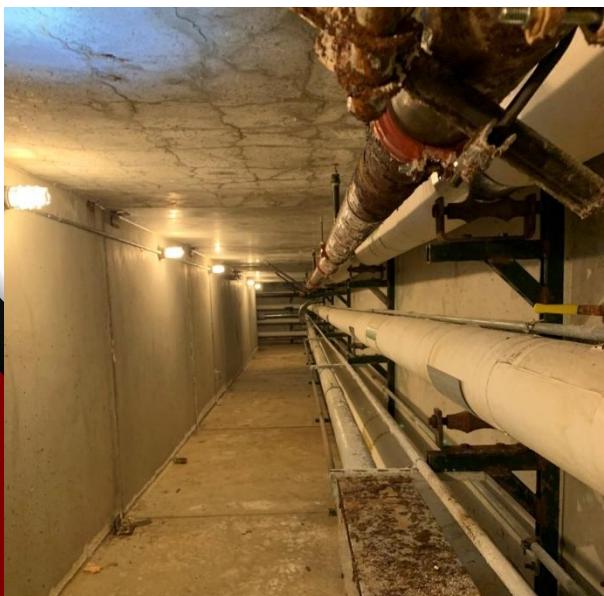
The existing tunnel lid had begun to fail, showing visible cracks, signs of water penetration into the tunnel and even a partial collapse. This created unsafe conditions inside the tunnels and hindered access to the hospital staff and patients.

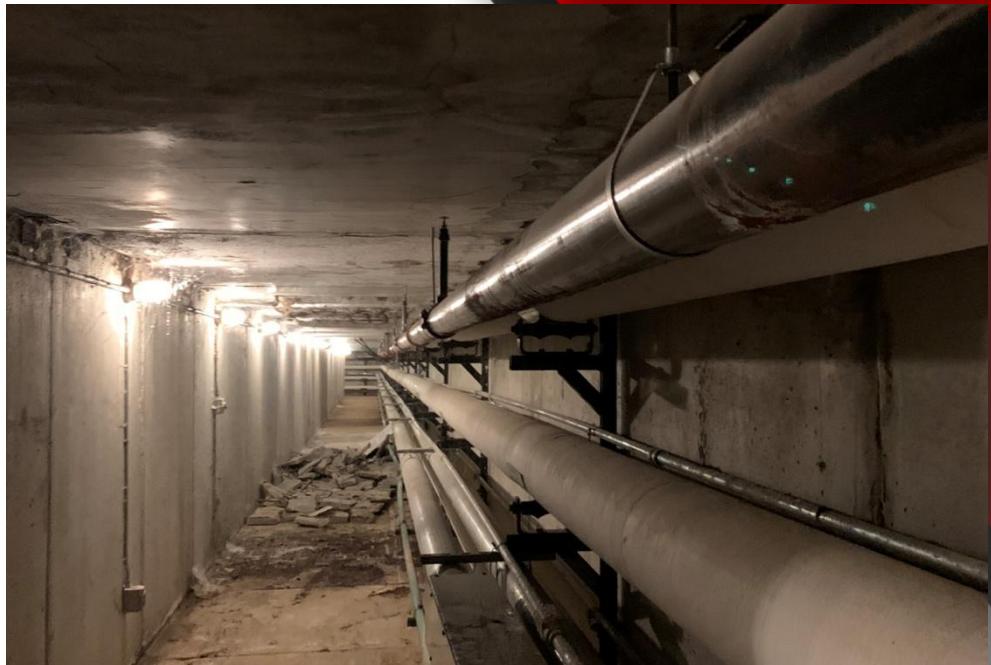
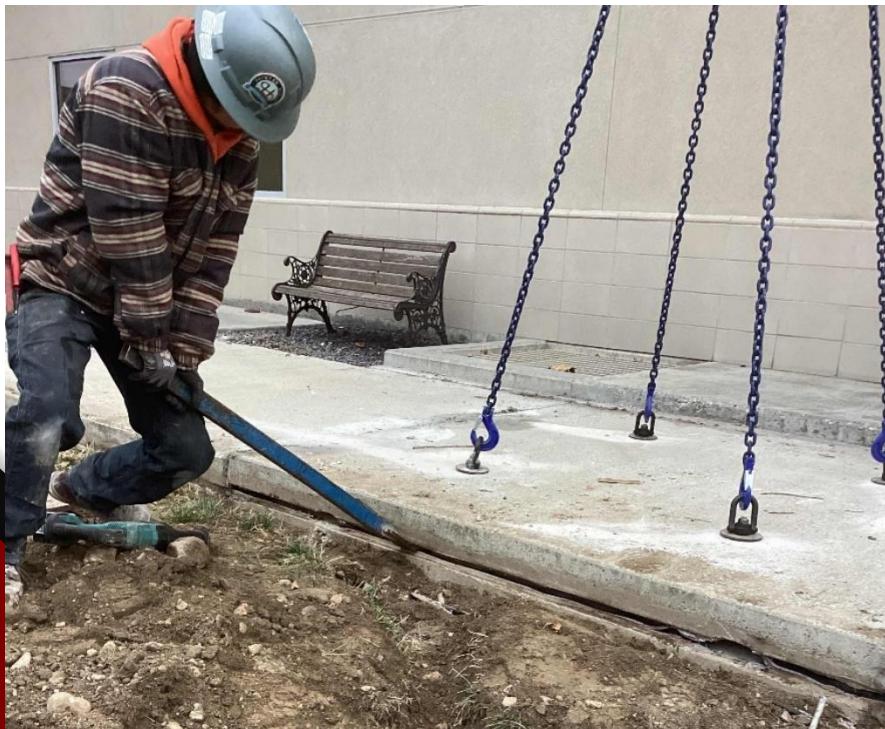
Retrofitting a concrete structure that had already settled and had sustained some minor damage created more challenges beyond the standard field verifications and installation. To ensure the new lid would perform the way the owner and engineer intended, Clearwater took a creative approach in determining the number of precast sections and identifying sections that needed to be cast in place.

Due to the complexities of the existing conditions multiple precast panels sizes were not finalized until most panel installation was completed. This was a deliberate strategy to avoid waste and rework ensuring a perfect fit for the last few panels.

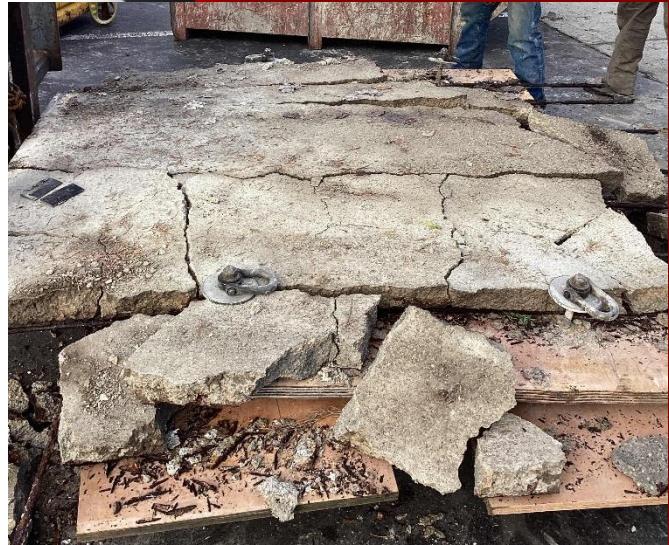
The removal of the panels in the worst conditions required more attention and planning. Clearwater approached the task carefully and focused on the safety of our crew. Clearwater also had to preserve and protect the existing utilities inside the tunnel. Before any lifting took place, our team developed a detailed plan to stabilize each section. This prevented damage to the structure, and the hospital's 6" pure oxygen line. This critical line ran the length of the tunnel, providing life sustaining oxygen to the hospital's patients.

To accomplish this, Clearwater used 1.25" superior-grade plywood as a reinforcement layer and securely anchored picking eyes through the plywood and the existing lid. This distributed the weight evenly and ensured that the fragile panels remained intact during removal. By taking these extra precautions and clear communication between the crew, the team was able to safely lift the deteriorated panels from the tunnel without incident.

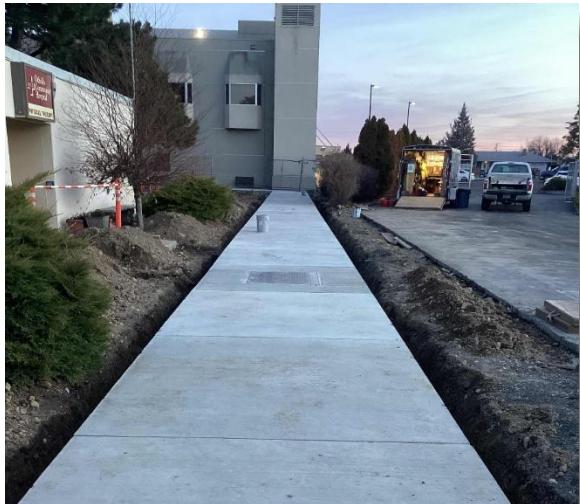
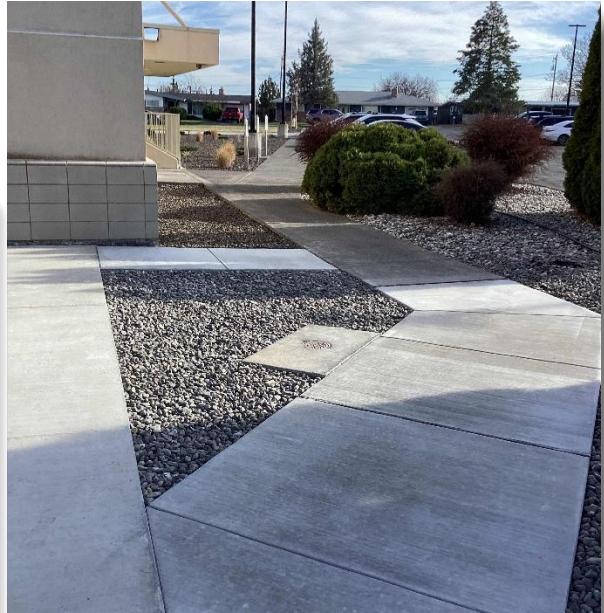
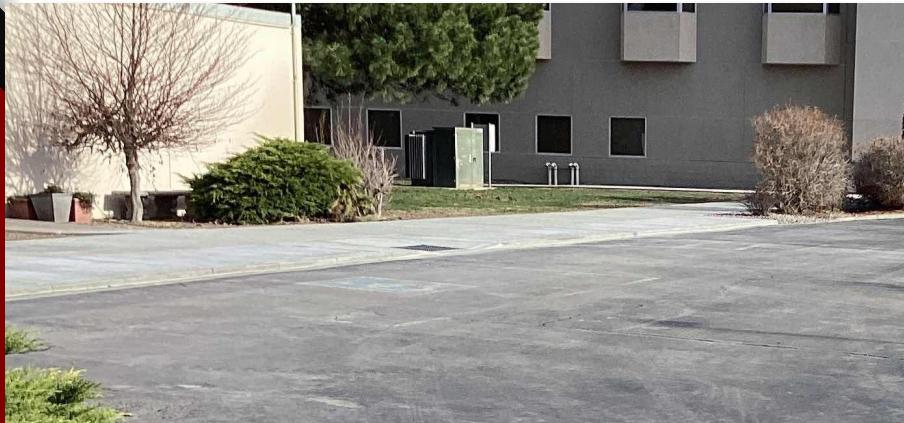
The final appearance of the tunnel lid sections blended with the surrounding sidewalks. The project included sidewalks outlined in the original contract as well as additional sidewalks added after construction began.

Our skilled carpenters formed and poured the concrete sidewalks along side the tunnel, creating improved access routes around the hospital. The quality of the finish work speaks for itself; you would be hard pressed to tell where the tunnel lid ends and the sidewalk begins.

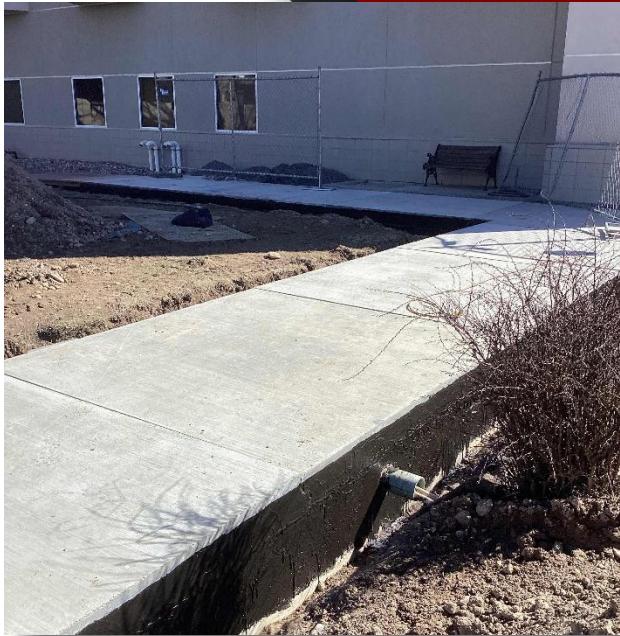
The project scope included the application of a waterproofing system as well as joint sealants. Clearwater successfully installed the new tunnel lid before the temperatures were consistently freezing. The project was granted a suspension of working days, this allowed Clearwater to come back during a heat wave.

Once temperatures improved, Clearwater resumed work to complete the installation of the waterproofing, joint sealant and additional sidewalk pours. Despite the temporary suspension of work the project was completed on time and within the original project schedule, a testament to our team's exceptional planning, ability to adapt and commitment to our work and owners under all conditions.
